Service Manual

Energy Recovery Ventilator

FV-15VE1T

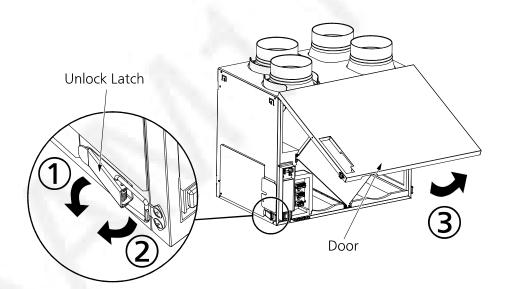
- Electric shock may result. Disconnect power by switching off main switch, then unplug before working on the unit. If a standby switch is connected, it is recommended to switch it off first.
- Routine maintenance must be performed every 2 or 3 months. clogged filters may cause condensation on the unit due to air flow reduction.
- Please wear gloves to avoid pinching fingers during maintenance.
- Please pay attention to dust, condensation water, or parts that may drop down when the door is opened.
- \bigcirc Never use gasoline, benzene, thinner or any other such chemicals to clean the ERV.
- \bigcirc Do not allow water to enter ERV.
- \bigcirc Do not immerse resin parts in water over 60 $^{\circ}$ C.
- 1 Open the door by unlocking the latches.

Clean the OA filter, RA filter and energy recovery core.

Vacuum

3 Reinstall the filters.

- 4 Reinstall and close door by locking the latches.
- Connect power and press filter reset button. When the unit beeps, the filter reset timer will be reset.
